“GEOSYNTHETICS: INNOVATIVE SUSTAINABLE SOLUTIONS FOR CIVIL ENGINEERING PROJECTS – CASE STUDIES”

Prof. Mahesh D. Desai (Ph.D.),

Prof. Ravin M. Tailor,

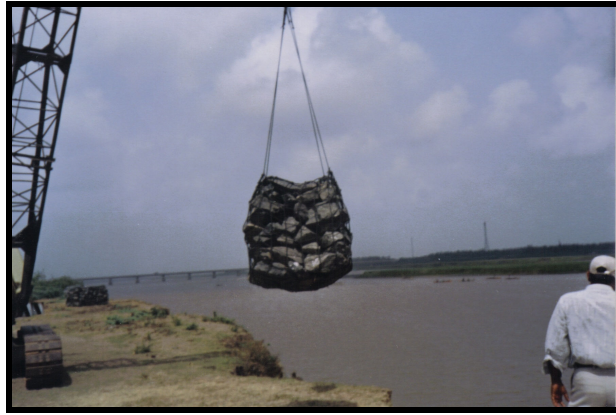
Fig.2: Rope Gabbion laying under water on riverbank at Umra, Surat

Rope gabions have advantages of placement in under water conditions or tidal waves. Both Georopes and wire-mesh mattresses are designed to suit slope protections and foundations on soft soils for structures and embankments. Fig.2 shows the laying of Roper Gabbion underwater.

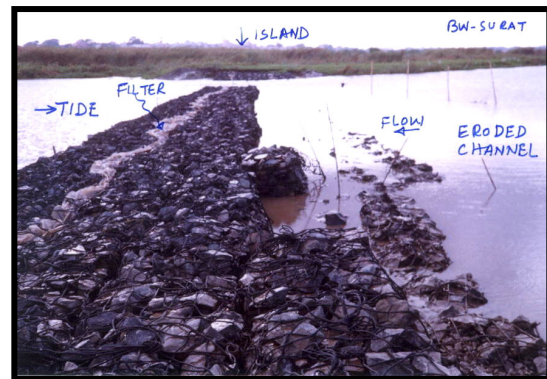
Fig. 8: Laying of Gabbions, Filter in stages in tidal zone.

Typical techniques of approaching tidal river for land fill by spurs with dyke (parallel to bank) was used for stage filling of soli wastes. Once the tidal level was crossed work, was conventional. Fig. 7, 8, 9, 10 shows the treatment provided at site.

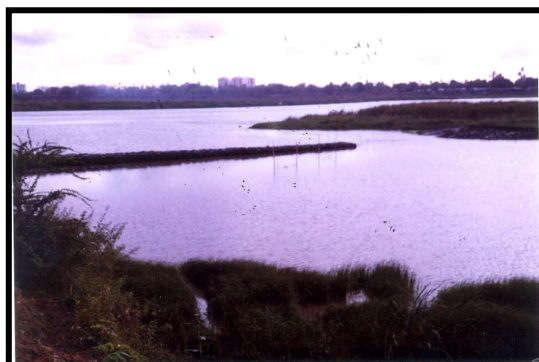
Fig. 9: Closer of Break Water to island with tide water

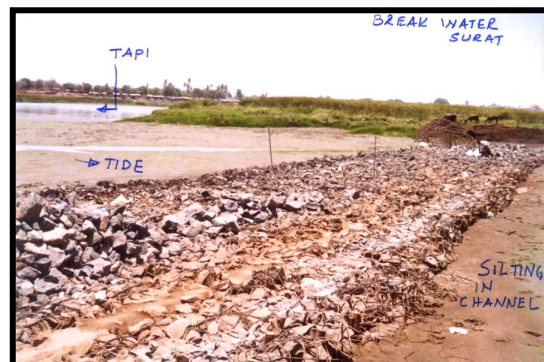
Fig.10: Silting on Weir & Island side (2000).

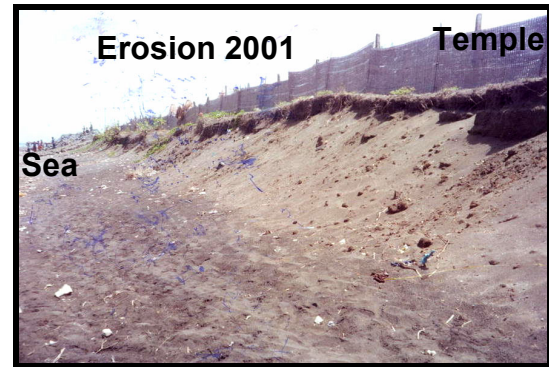
Fig. 12: Eroded sandy slope 4 m to 5m high.

The sea wave erosion eroded 20 - 30 m of bank near temple as shown in Fig. 11 & Fig. 12 endangering temple foundations. Wire rope Gabbions, hand placed stones and use of Geofilter, planned, executed and maintained as shown in Fig. 13, 14, 15, 16 explain success story.

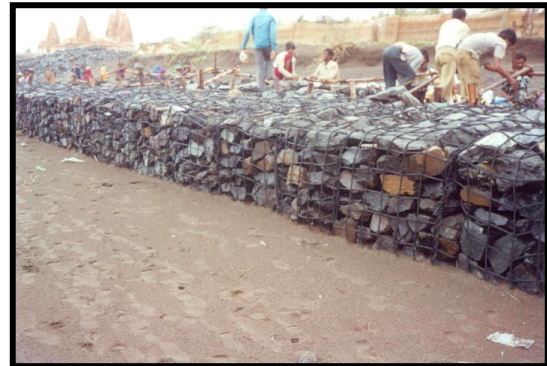
Fig. 14: Final layout, backfill with Sand at BAPS, Tithal.

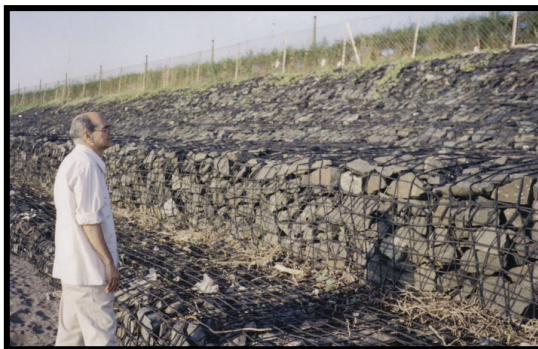
Fig. 15: Final finished level at BAPS, Tithal in year 2000

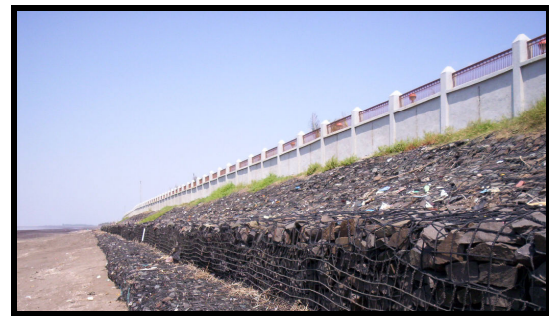
Fig. 16: Sea bank profile in October 2009 at BAPS Temple, Tithal.

The hydraulic alignment & cut off gabions provided good sand beach at site.

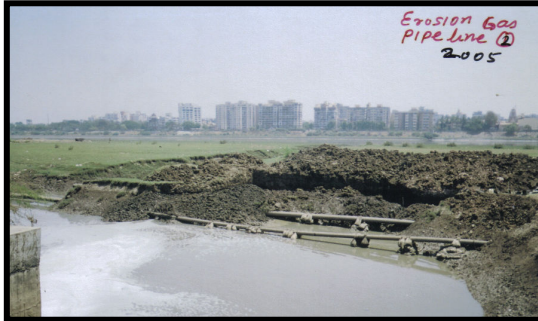
Fig. 17: Gas Pipeline Bed Erosion, Pal, Surat.

The pressure mains of gas, for safety, requires loading on the top 2 X pressure. Loss cover on top by erosion had to be created on emergency basis for Surat & GALE line at Kaveri River. Abrama project was only designed. Fig. 17, 18, 19, 20 shows adoption of Geosynthetics for erosion, surcharge and hydraulics of river.

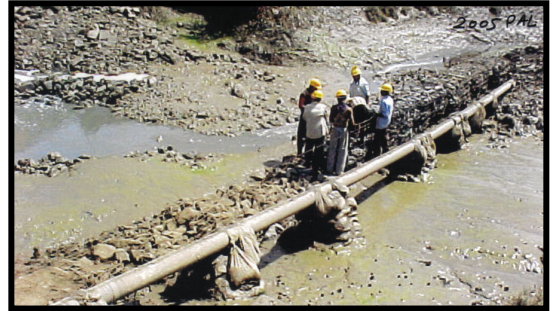
Fig. 18: Erosion protection treatment by Gabion & Geo-filer: Geo-synthetics.

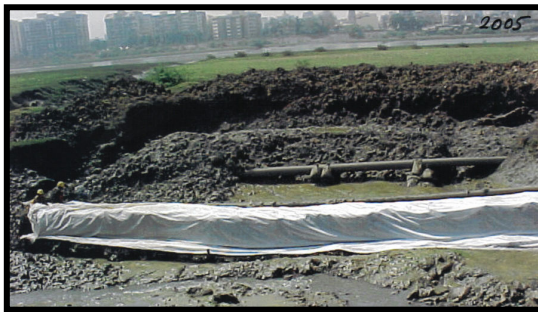
Fig. 19: Protection work in progress at Gas pipeline, Surat.

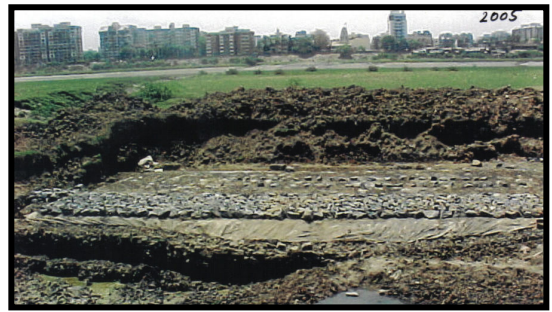
Fig. 20: Finalized profile protection against erosion at Surat.

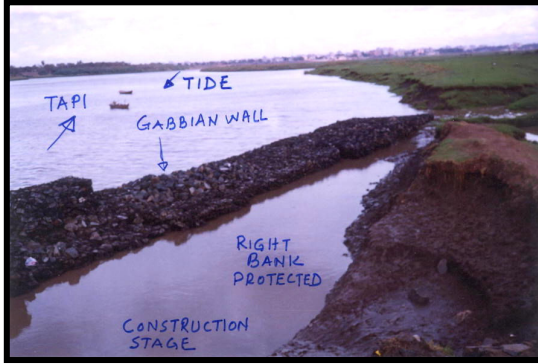
Fig. 25: Construction phase with free tide movement.

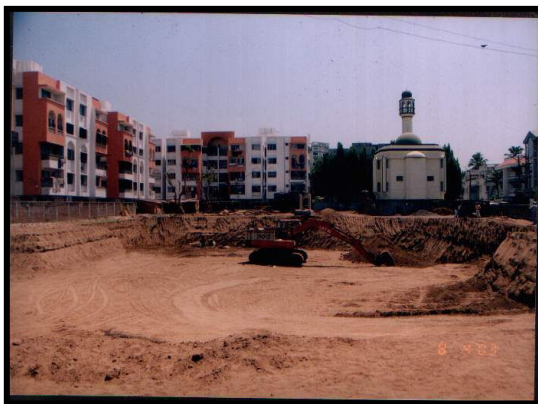
Fig. 28: Excavation of Creek zone at ABRAR apartment.

The ABRAR apartment complex (2003) Fig. 27 is typical illustration. Fig. 28 shows excavation in loose silt and fine sand to more than 3 m. Laying Geofilter in total area, placing & compacting excavated soil in layers as shown in Fig. 29 to prepare base for foundations is example to provide net Safe Bearing Capacity of 30 T/m^2 and permissible differential settlement 25 mm. The structure is on bank of river Tapti.

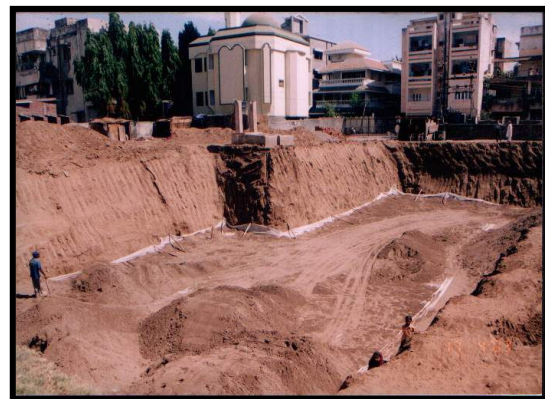
Fig. 29: Providing fabric & fill & compacting in layers

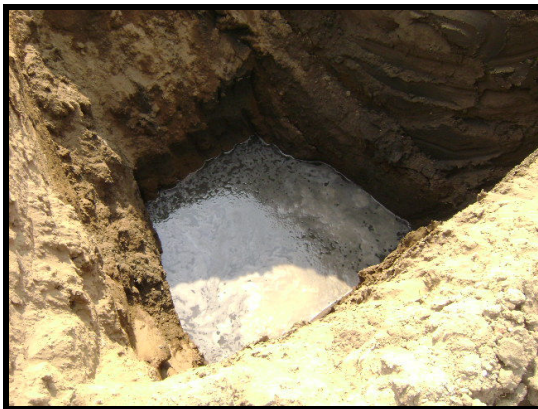
Fig. 32: Ground water seepage at foundation level after excavation at SIECC Sarsana.

Finished structure of South Gujarat Chamber of Commerce & Industry's exhibition pavilion SIECC at Sarsana shown by Fig. 30 & Fig. 31 had seepage and loose foundation soil which is incapable to take design stress of 20 T/m^2 . Structural designer, contractor were convinced to use high tensile Geofilter with sand fill as shown in Fig. 32, 33, 34, 35.

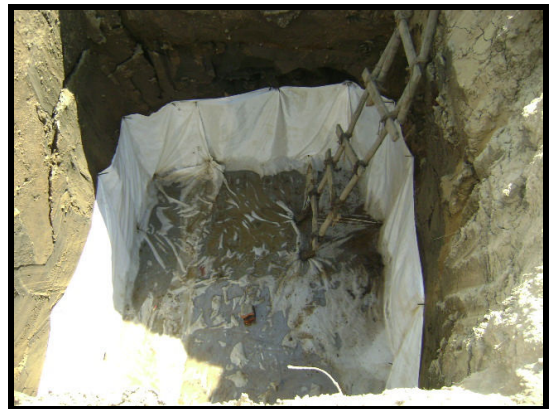
Fig. 33: Laying of Geotextile at foundation level for SIECC.

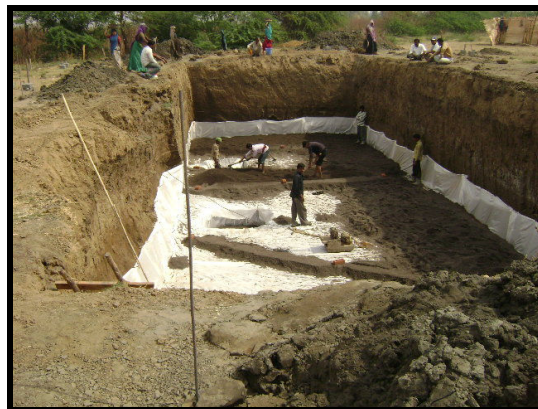
Fig. 34: Proving Sand layer above Geotextile at SIECC.

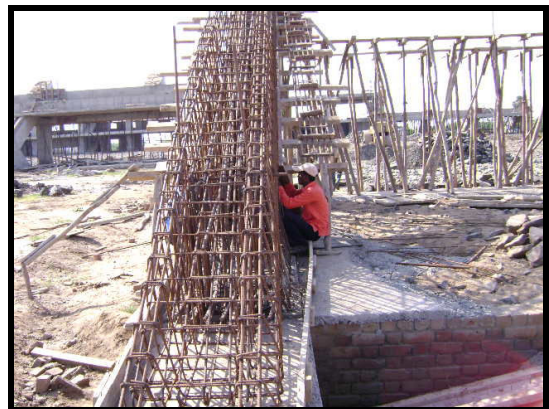
Fig. 35: Foundation above ground level on treated soil at SIECC.
